Technical Evaluation of the Gold King Mine Incident

San Juan County, Colorado

October 2015

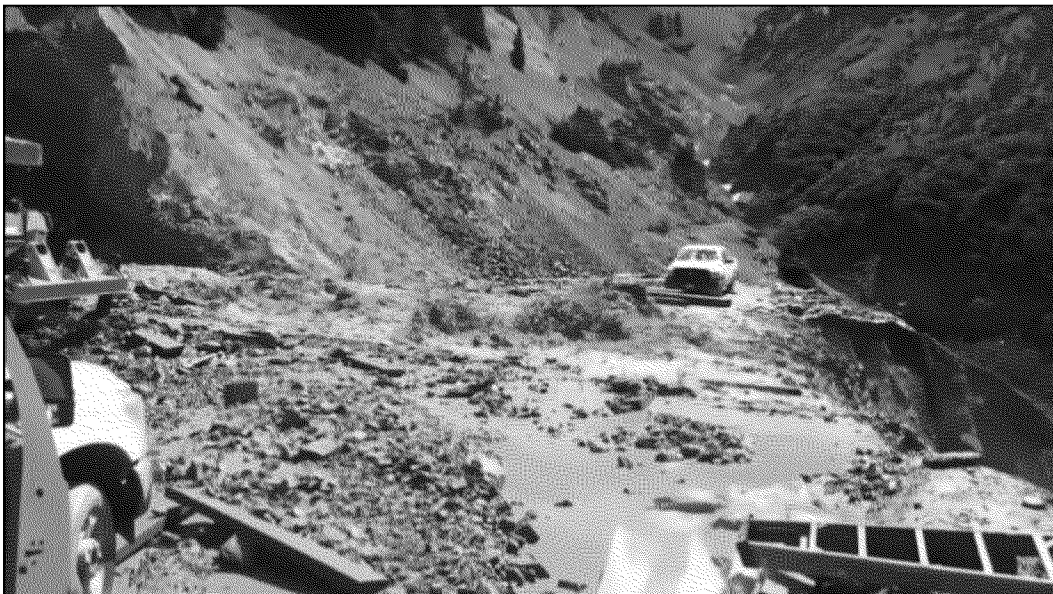
Figure 54.—Photograph showing the peak outflow from the blowout. The waste-rock dump is eroding on the right side of the photograph (still frame extracted from a video taken on August 5, 2015, at approximately 10:57 a.m.).

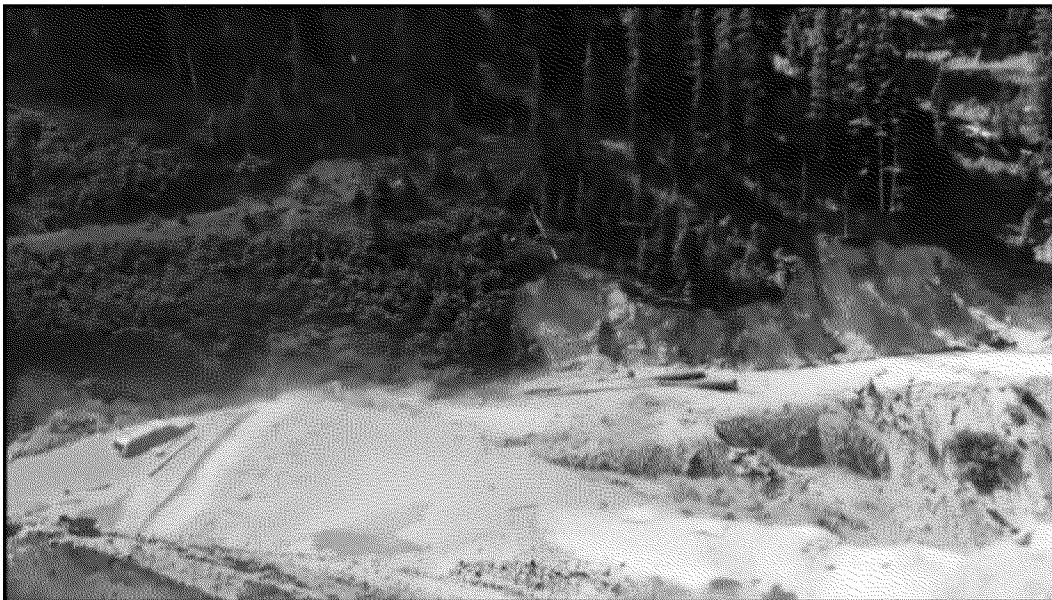
Figure 56.—Photograph showing at left, the inundation of a vehicle parked near the base of the waste-rock dump, and on the right water overwhelming the access road and cascading down into the North Fork of Cement Creek (still frame extracted from a video taken on August 5, 2015, at approximately 10:57 a.m.).
